**Flood Control Project Maintenance
Levee Inspections**

Maintenance Issue Types Only, Levee Inspection Report By Mile - Spring 2019

Reclamation District No. 2085 Kasson

Waterway	Bank	Unit Miles	Inspection Start/End	Inspector
Unit No. 01 San Joaquin River	Left	5.29	05/09/2019 05/09/2019	Alberto De Leon

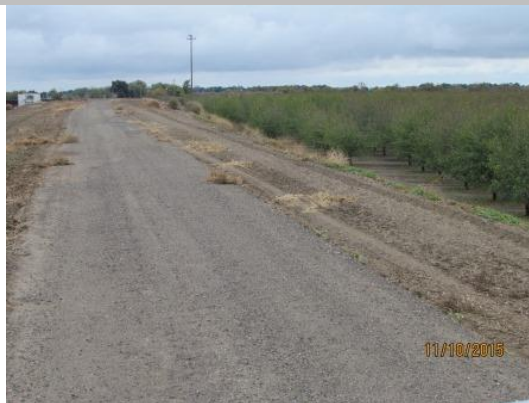
Photo 1 of 1 : SP_2019_RD2085_113_19_20190313_00011.jpg

LM Start	0.12	Rating **	A/W	Issue No.	19
LM End	0.47	Issue Type +	Ma	Location *	CR
Category	Earthen Levee			GPS Latitude/Longitude	
				Start	End
Item	Crown Surface / Depressions / Rutting			37.719052 °	37.723246 °
				-121.302928 °	-121.299492 °
DWR ID	DWR_RD2085_01_f_2015_19				
Comment Code					
C1 : Add appropriate material and re-grade the levee to bring the crown above the design elevation.					
Inspector Comment					
Disking on the levee shoulder. Make sure the water drains evenly to the slopes.

View of the disking on the levee crown shoulder.

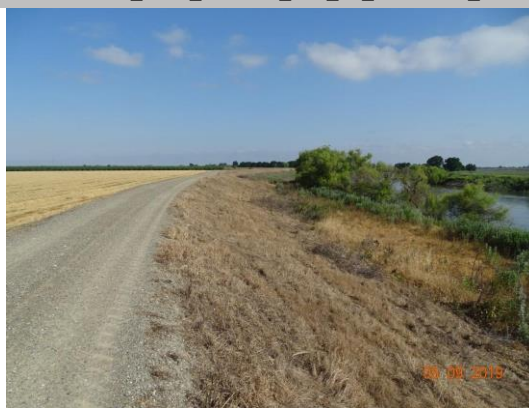
Photo 1 of 1 : SP_2019_RD2085_113_23_20190514_00059.jpg

LM Start	0.47	Rating **	A	Issue No.	23
LM End	4.40	Issue Type +	Ma	Location *	WS
Category	Earthen Levee			GPS Latitude/Longitude	
				Start	End
Item	Vegetation			37.723246 °	37.681863 °
				-121.299492 °	-121.269856 °
DWR ID	DWR_RD2085_01_s_2019_23				
Comment Code					
V1 : Control annual grass and weeds on the levee slopes and easements.					
Inspector Comment					
Annual vegetation is well maintained.

Typical view of vegetation on waterside slope. (Spring 2019)

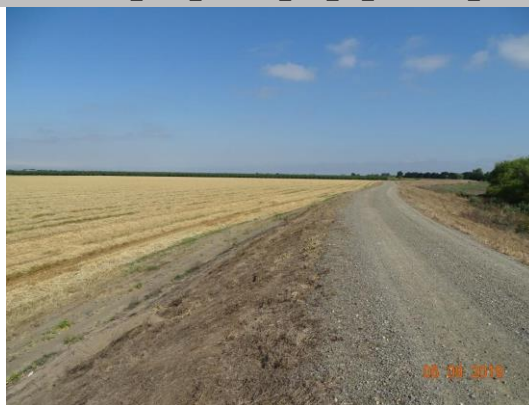
Photo 1 of 1 : SP_2019_RD2085_113_25_20190514_00058.jpg

LM Start	0.47	Rating **	A	Issue No.	25
LM End	4.40	Issue Type +	Ma	Location *	LS
Category	Earthen Levee			GPS Latitude/Longitude	
				Start	End
Item	Vegetation			37.723246 °	37.681863 °
				-121.299492 °	-121.269856 °
DWR ID	DWR_RD2085_01_s_2019_25				
Comment Code					
V1 : Control annual grass and weeds on the levee slopes and easements.					
Inspector Comment					
Annual vegetation is well maintained.

Typical view of vegetation on landside slope. (Spring 2019)

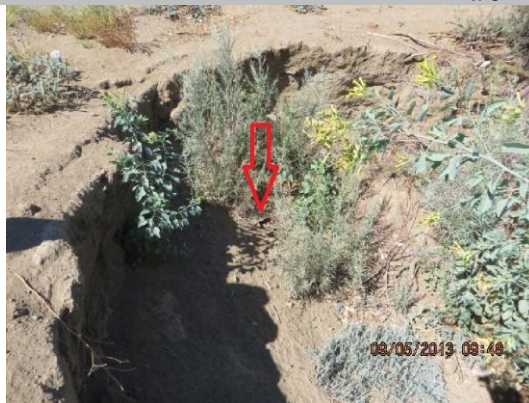
Photo 1 of 3 : UCIP_SP_2019_52493_62262.jpg

Comment Code					
Inspector Comment					
FS_ID:52493 DS_ID:20677 EP_NO: N/A Repair Type: No Action Needed Crossing Status: Found UCIP Comments: Pipe has been removed by LMA.Previous:Pipe abandoned. Erosion around pipe on WS slope. Pipe severely corroded. Pier badly damaged. FIELD_STRUCT_DESC: *REMOVED* 14-inch steel drainage pipe through the levee, 4.5 feet below the crown. Pump on pile structure in ditch on the landside (LS). Siphon breaker in corrugated metal pipe (CMP) riser on the waterside (WS) shoulder. Pipe removed by LMA. (Permit Application No. T2013179, 2014 - Surinder Sandhu, submitted to CVFPB. Permit was not needed per CVFPB review). [Additional Reference(s): DWR Levee Log, 2005. USACE San Joaquin O&M Manual 11, 1968, (HLM 0.47)]. FS Date: 9/5/2013

(Pipe removed by LMA)Pipe on WS with erosion into levee slope.

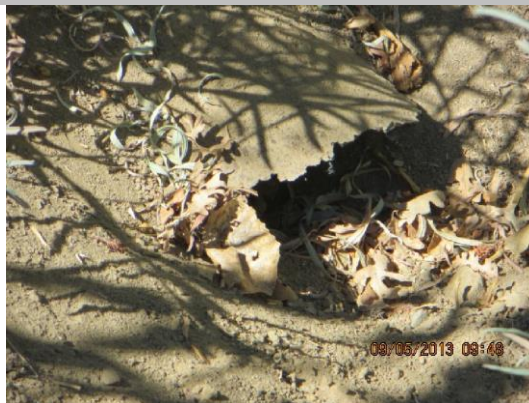
Photo 2 of 3 : UCIP_SP_2019_52493_62261.jpg

Pipe removed from WS toe.

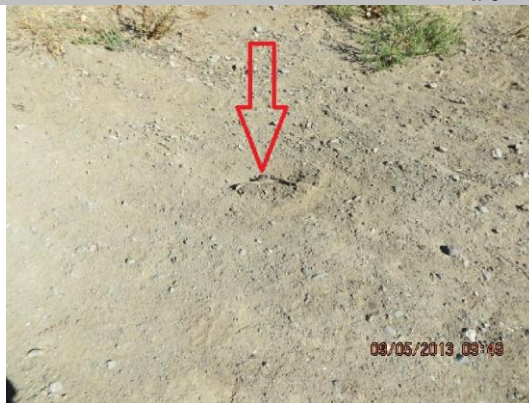
Photo 3 of 3 : UCIP_SP_2019_52493_62260.jpg

Siphon breaker in 24-inch CMP riser on WS shoulder was removed by LMA.

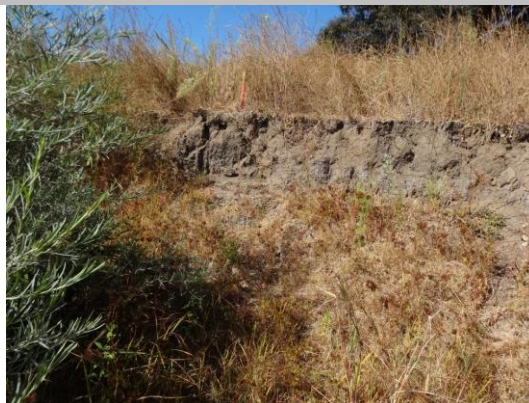
Photo 3 of 4 : SP_2019_RD2085_113_2_20190313_00007.jpg

Item	DWR Erosion Survey			37.703094 °	37.703094 °	
				-121.274894 °	-121.274894 °	
DWR ID	RD2085U01RM66.5					
Comment Code						
Inspector Comment						
11/1/2018: This site was repaired within the past week.						
10/04/2017: The erosion has progressed significantly toward the levee toe.						
07/08/2016: No significant change observed.						
09/10/2015: No significant change observed. Signs of animal activity are present.						
09/10/2014: No significant change observed.						
09/20/2013: No significant change in erosion observed. More vegetation at the site.						
12/04/2012: The erosion has progressed remarkably toward levee, extended to the up-and downstream of the original pocket erosion. Trees and dense bush are present at the site. Animal burrow holes are visible, and possibly can cause seepage.						
09/22/2010: No significant change observed. There is little visibility due to seasonal grass on the berm and slope.

Direct view of the erosion. Note the sign of erosion expansion.

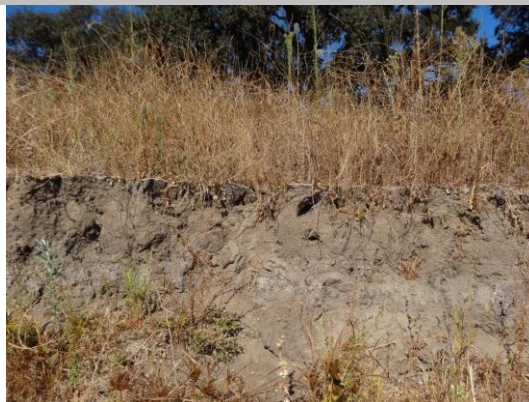
Photo 4 of 4 : SP_2019_RD2085_113_2_20190313_00008.jpg

Close view of the erosion.

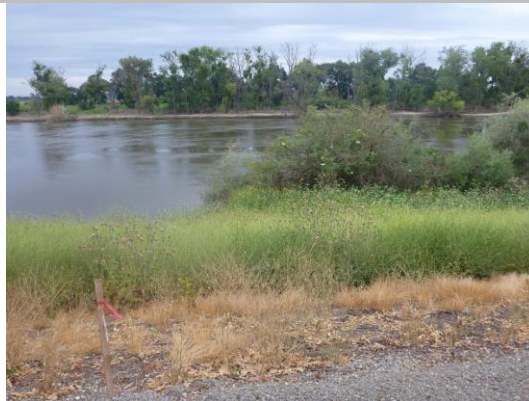
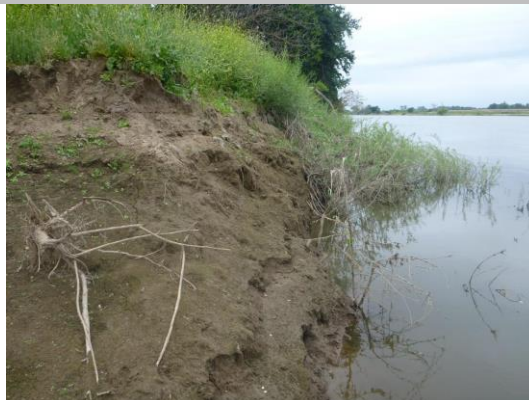
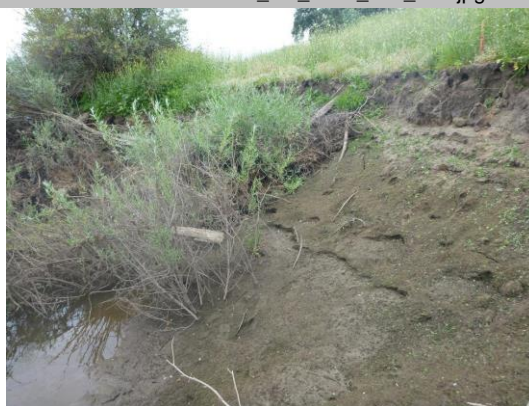
LM Start	2.57	Rating **	A/W	Issue No.	48
LM End		Issue Type +	Ma	Location *	
Category	Supplemental			GPS Latitude/Longitude	
				Start	End
Item	2017 Storm Damage			37.703094 °	°
				-121.274894 °	°
DWR ID	DWR_RD2085_01_f_2017_48				
Comment Code					
Inspector Comment					
Levee Evaluation Comments					
Description:					
Site ID No:105					
Site Designation:FSRP-13-55					
Repair Type: Erosion					
Rating:Serious					
Field Date:6/8/2017					
Notes: This site is repaired as of this inspection date. Fall 2018.

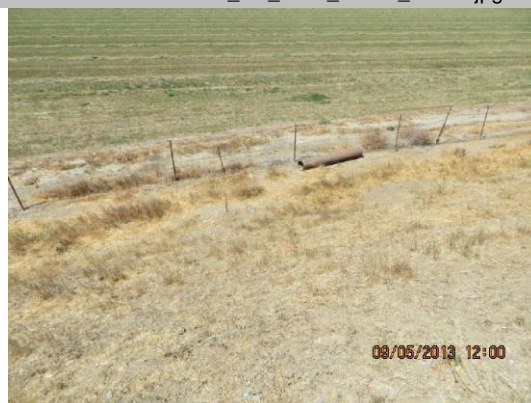
Photo 1 of 3 : UCIP_SP_2019_19433_32990.jpg

LM Start	3.30	Rating **	M	Issue No.	56
LM End	3.30	Issue Type +	Ma	Location *	
Category	Supplemental			GPS Latitude/Longitude	
				Start	End
Item	DWR UCIP LMA Responsibility			37.693618 °	37.693618 °
				-121.277639 °	-121.277639 °
DWR ID	20693				
Comment Code					
Inspector Comment					
FS_ID:19433 DS_ID:20693 EP_NO: N/A Repair Type: Non-Urgent Crossing Status: Found UCIP Comments: Pipe appears abandoned and should be done so properly. FIELD_STRUCT_DESC: *ABANDONED* 10-inch steel storm drainage pipe through the levee, 4 feet below the crown. T-post marks location of pipe at the landside (LS) toe. Steel plate welded over pipe on the waterside (WS) slope. [Additional Reference(s): USACE San Joaquin O&M Manual 11, 1968, (HLM 3.34), As-Built Drawings available, DWG 7-4-1685]. FS Date: 9/5/2013

T-post marking pipe end on LS toe. 10-inch pipe debris on LS toe.

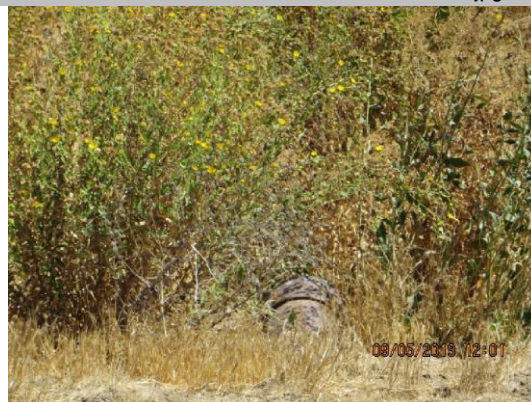
Photo 2 of 3 : UCIP_SP_2019_19433_32989.jpg

Pipe visible on WS slope.

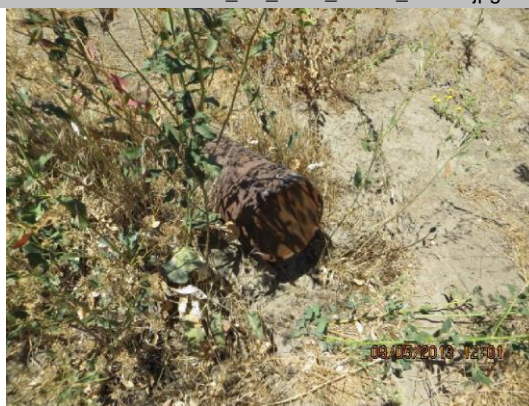
Photo 3 of 3 : UCIP_SP_2019_19433_32988.jpg

Pipe visible on WS slope. Steel plate welded over end.

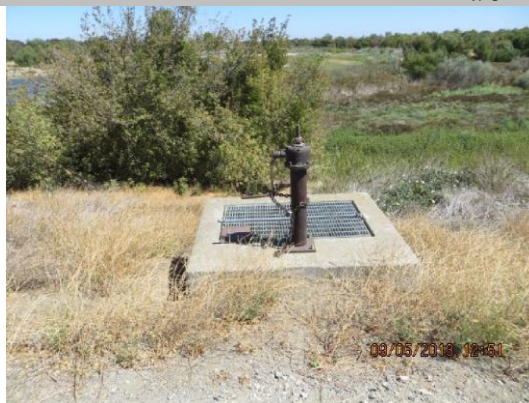
Photo 1 of 3 : UCIP_SP_2019_19436_32997.jpg

LM Start	3.80	Rating **	A/W	Issue No.	58
LM End	3.80	Issue Type +	Ma	Location *	
Category	Supplemental			GPS Latitude/Longitude	
				Start	End
Item	DWR UCIP LMA Responsibility			37.686976 °	37.686976 °
				-121.276838 °	-121.276838 °
DWR ID	20683				
Comment Code					
Inspector Comment					
FS_ID:19436 DS_ID:20683 EP_NO: N/A Repair Type: No Action Needed Crossing Status: Found UCIP Comments: FIELD_STRUCT_DESC: 30-inch by 30-inch reinforced concrete box drainage culvert through the levee, 12 feet below the crown. Slide gate in concrete riser on the waterside (WS) slope. Concrete U-shaped headwalls on both ends. Flap gate on the WS end. Two concrete cutoff walls. [Additional Reference(s): DWR Levee Log, 2005. USACE San Joaquin O&M Manual 11, 1968, (HLM 3.71)]. FS Date: 9/5/2013 9:49:55 AM

Slide gate in Concrete riser on WS shoulder.

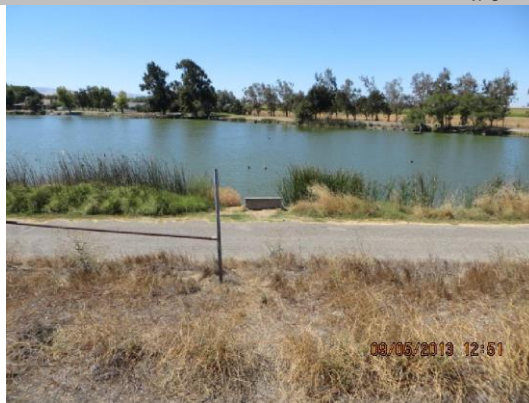
Photo 2 of 3 : UCIP_SP_2019_19436_32996.jpg

Concrete headwall off LS toe.

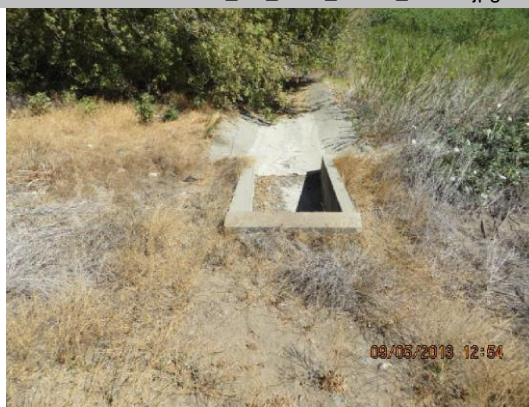
Photo 3 of 3 : UCIP_SP_2019_19436_32995.jpg

Concrete U-shaped headwall on WS slope.

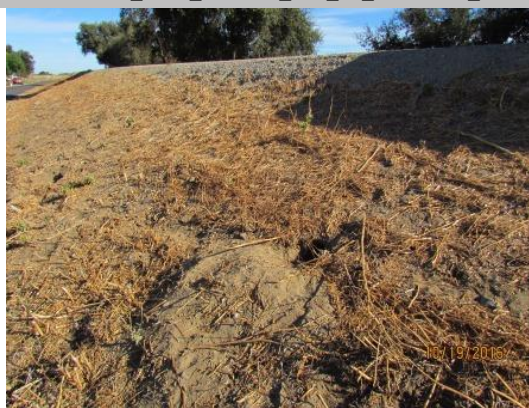
Photo 1 of 1 : SP_2019_RD2085_113_36_20190313_00020.jpg

View of the rodent holes on the levee slope.

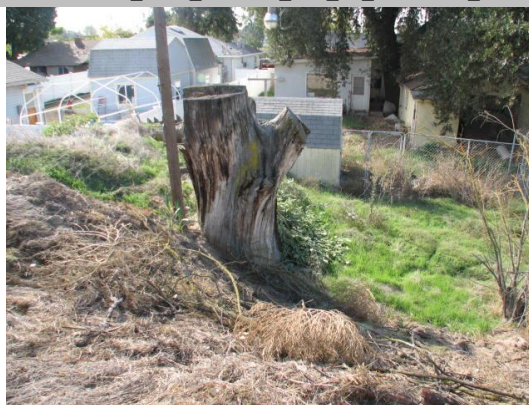
Photo 1 of 1 : SP_2019_RD2085_113_32_20190313_00017.jpg

LM Start	4.46	Rating **	N	Issue No.	32
LM End	4.46	Issue Type +	Ma	Location *	LS
Category	Earthen Levee			GPS Latitude/Longitude	
				Start	End
Item	Trim / Thin Trees			37.681605 °	37.681605 °
				-121.268882 °	-121.268882 °
DWR ID	DWR_RD2085_01_s_2012_32				
Comment Code					
T5 : Tree stumps.					
Inspector Comment

11/03/2011 Large stump on landside slope.

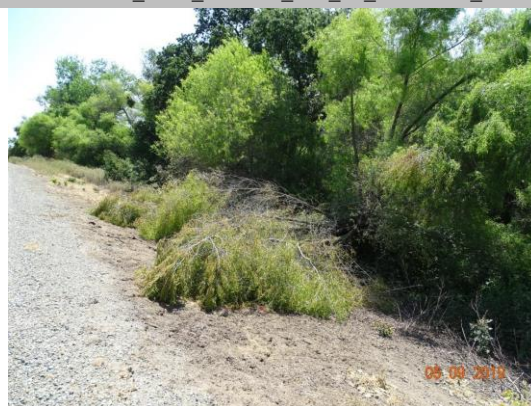
Photo 1 of 1 : SP_2019_RD2085_113_44_20190514_00061.jpg

LM Start	4.98	Rating **	U	Issue No.	44
LM End	4.98	Issue Type +	Ma	Location *	WS
Category	Earthen Levee			GPS Latitude/Longitude	
				Start	End
Item	Encroachments			37.677972 °	37.677972 °
				-121.268077 °	-121.268077 °
DWR ID	DWR_RD2085_01_s_2019_44				
Comment Code					
TR : Tree or limb					
Inspector Comment					
There are tree limb/branches broken on the waterside slope.

Broken tree limb on waterside slope. (Spring 2019)

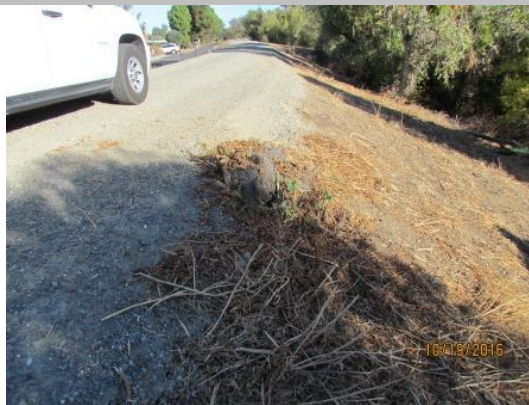
Photo 1 of 1 : SP_2019_RD2085_113_29_20190313_00016.jpg

LM Start	5.24	Rating **	N	Issue No.	29
LM End	5.24	Issue Type +	Ma	Location *	WS
Category	Earthen Levee			GPS Latitude/Longitude	
				Start	End
Item	Trim / Thin Trees			37.675099 °	37.675099 °
				-121.269264 °	-121.269264 °
DWR ID	DWR_RD2085_01_f_2015_29				
Comment Code					
T5 : Tree stumps.					
Inspector Comment

View of the tree stump.

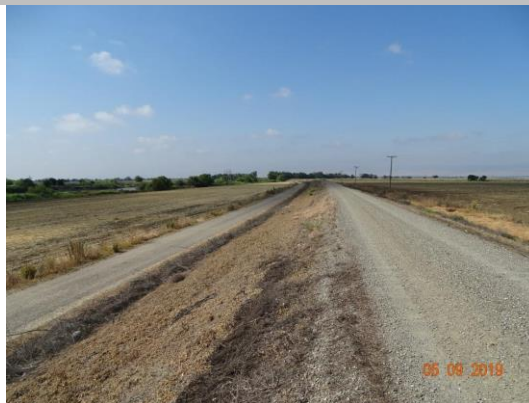
Photo 1 of 1 : SP_2019_RD2085_114_3_20190514_00001.jpg

Typical view of vegetation on waterside slope. (Spring 2019)

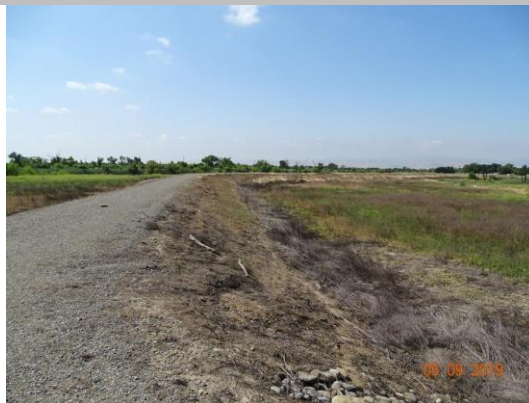
Photo 1 of 1 : SP_2019_RD2085_115_2_20190514_00005.jpg

Typical view of vegetation on waterslide slope. (Spring 2019)

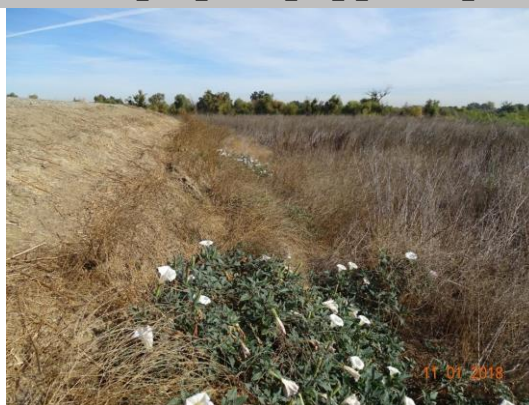
Photo 1 of 4 : SP_2019_RD2085_115_1_20190313_00001.jpg

LM Start	0.21	Rating **	U	Issue No.	1
LM End	0.23	Issue Type +	Ma	Location *	WS
Category	Earthen Levee			GPS Latitude/Longitude	
				Start	End
Item	Erosion / Bank Caving			37.682798 °	37.683052 °
				-121.262059 °	-121.261851 °
DWR ID	DWR_RD2085_03_s_2014_1				
Comment Code					
E2 : Schedule repair of erosion site prior to the next inspection.					
Inspector Comment					
Erosion of the waterside levee slope has been observed. The erosion is about 3 feet tall vertical from the slope to the base of projected levee toe.

View of erosion on the waterside slope. Fall 2018.

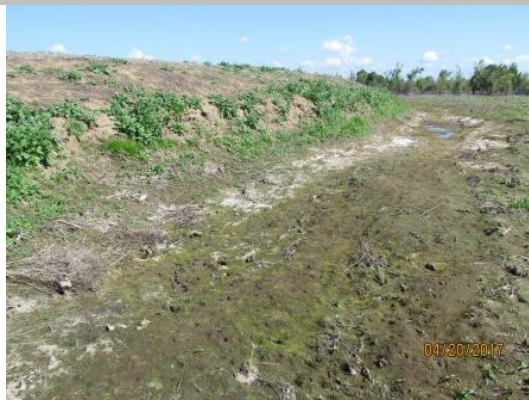
Photo 2 of 4 : SP_2019_RD2085_115_1_20190313_00002.jpg

View of the erosion at the waterside levee toe. Spring 2017.

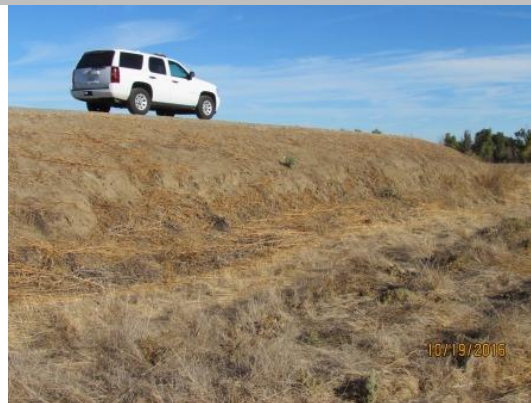
Photo 3 of 4 : SP_2019_RD2085_115_1_20190313_00003.jpg

View of the erosion at the waterside levee toe. Fall 2016.

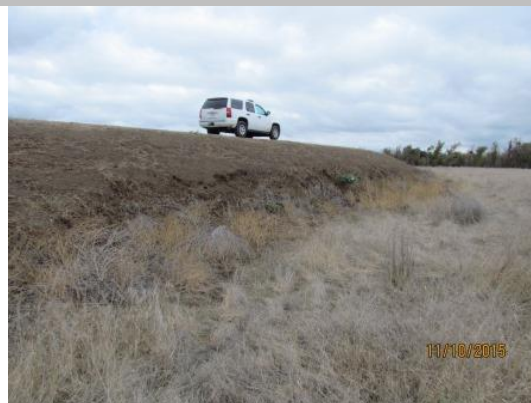
Photo 4 of 4 : SP_2019_RD2085_115_1_20190313_00004.jpg

View of the erosion at the waterside levee toe.
